**Flood Control Project Maintenance
Levee Inspections**

Fall 2016 Levee Maintenance Deficiency Summary Report

San Joaquin River Basin

Reclamation District No. 2031 Elliot

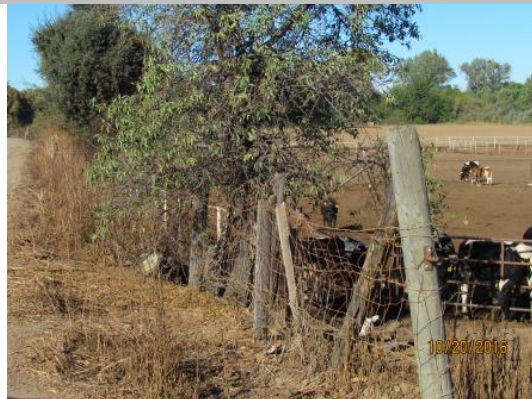
Photo 1 of 2 : FA_2016_RD2031_307_963_20161024_00086.jpg

View of the fence on the waterside levee slope. Fall 2016

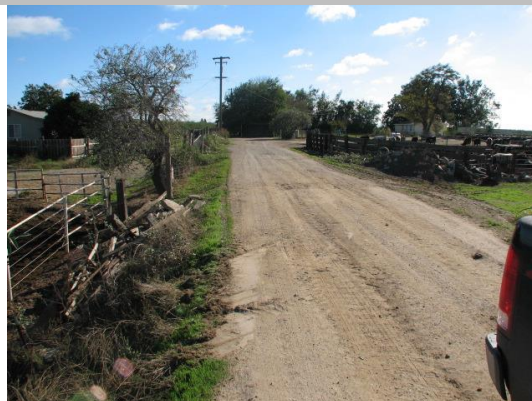
Photo 2 of 2 : FA_2016_RD2031_307_963_20160914_00040.jpg

Fall 2009 photo looking upstream at beginning of unit 1. Water side to the left.

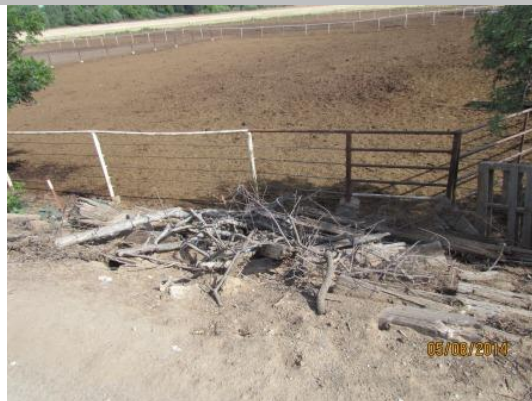
Photo 1 of 1 : FA_2016_RD2031_307_122_20160914_00037.jpg

LM Start	0.02	Rating **	U	Issue No.	122
LM End	0.02	Issue Type +	En	Location *	WS
Category	Earthen Levee			GPS Latitude/Longitude	
				Start	End
Item	Encroachments			37.710016 °	37.710016 °
				-121.155803 °	-121.155803 °
DWR ID	DWR_RD2031_01_s_2015_122				
Comment Code					
DE : Debris					
Inspector Comment

View of the pile of debris on the waterside levee slope.

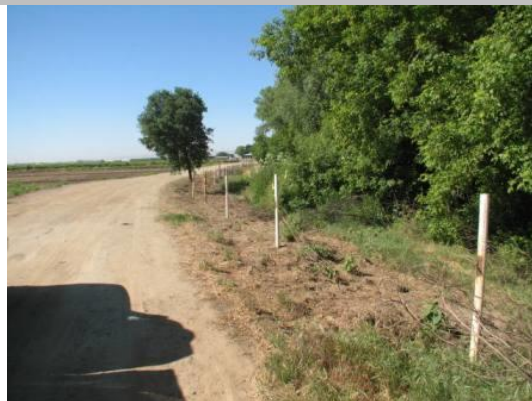
Photo 1 of 3 : FA_2016_RD2031_307_7_20160914_00009.jpg

05/10/2011 Fence on waterside prevents access to waterside slope.

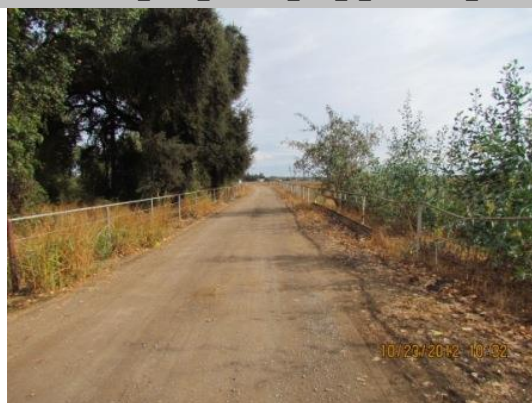
Photo 2 of 3 : FA_2016_RD2031_307_7_20160914_00010.jpg

View of fence obstructing access to waterside slope. Facing upstream.

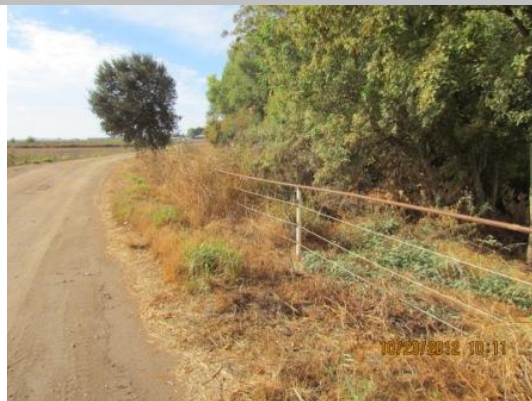
Photo 3 of 3 : FA_2016_RD2031_307_7_20160914_00011.jpg

View of fence on waterside slope facing downstream.

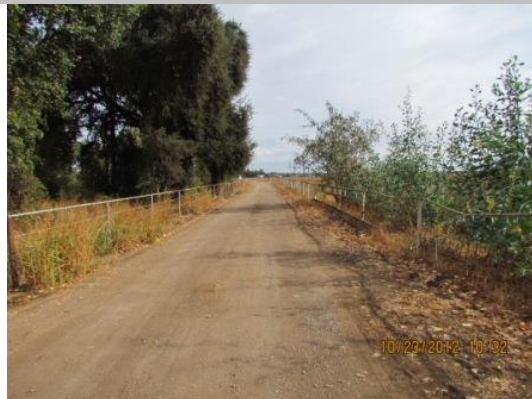
Photo 1 of 2 : FA_2016_RD2031_307_14_20160914_00014.jpg

View of fence on landside levee shoulder obstructing access to landside slope. Facing upstream.

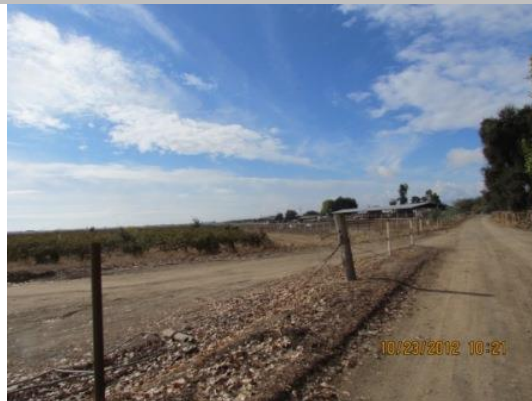
Photo 2 of 2 : FA_2016_RD2031_307_14_20160914_00015.jpg

View of fence on landside levee shoulder facing downstream.

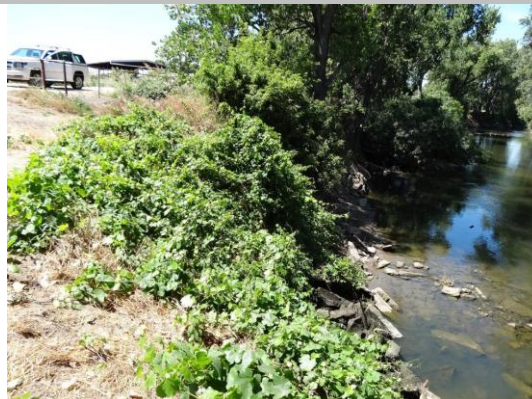
Photo 1 of 2 : SJR2016_RD2031U01RM0.48_1.jpg

07/25/2016: No significant change observed.
 08/28/2015: No significant change observed.
 07/31/2014: No significant change observed.
 09/10/2013: No significant change observed.
 07/18/2012: No significant change observed.
 08/18/2011: No significant change observed on site. Debris that blocks the irrigation outlet is visible.
 10/19/2010: No significant change observed on site. Sloughing of the bank is occurring adjacent to an irrigation outlet structure. There is moderate to heavy vegetation along the bank that is well established. Broken chunks and slabs of concrete are used as rip rap and line the outside of the irrigation outlet structure. However, much of the rip rap along the slope is sloughing and could possibly lead to future slope instability.
 08/05/2010: Recommended as a local maintenance issue, per CLRO.
 08/20/2009: No major change observed since last visit; 1 inch fissure cracks developing on the slope; rip rap is showing signs of sloughing; recommend as local maintenance issue; site was previously rated "U".

Direct view of the site.

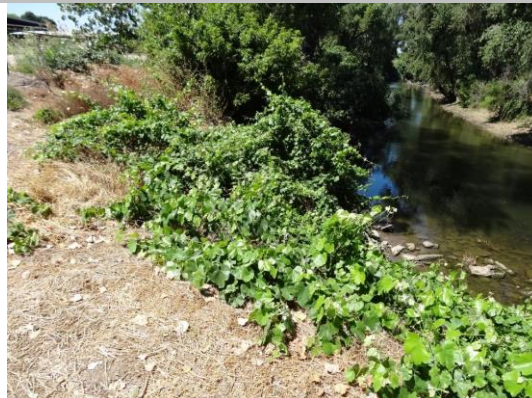
Photo 2 of 2 : SJR2016_RD2031U01RM0.48_3.jpg

View of the current condition of the bank slope just above the irrigation outlet.

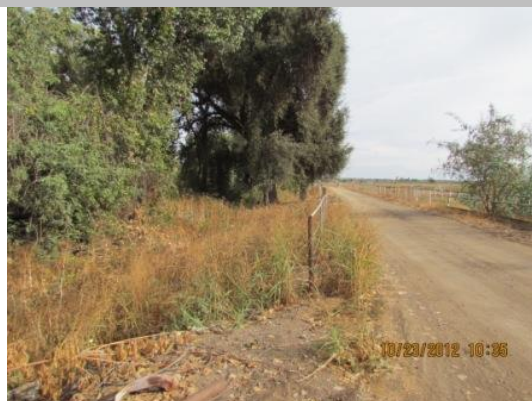
Photo 2 of 3 : FA_2016_RD2031_307_2_20160914_00004.jpg

View of vegetation on waterside slope. Facing upstream.

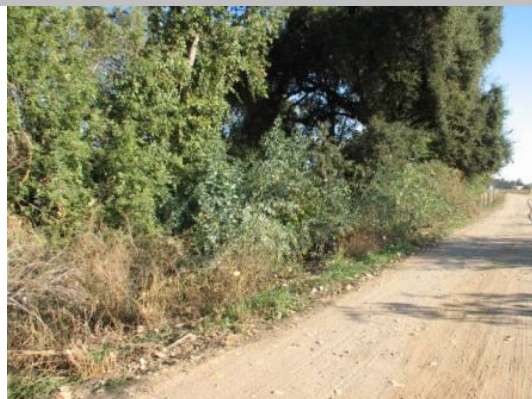
Photo 3 of 3 : FA_2016_RD2031_307_2_20160914_00005.jpg

10/26/2011 Updated photo of waterside vegetation.

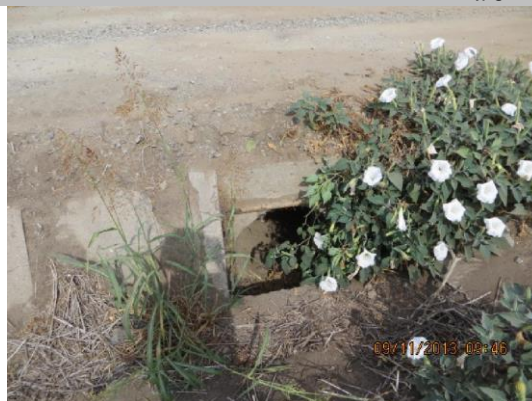
Photo 1 of 2 : UCIP_FA_2016_20046_33946.jpg

LM Start	0.72	Rating **	M	Issue No.	984
LM End	0.72	Issue Type +	En	Location *	LS
Category	Supplemental			GPS Latitude/Longitude	
				Start	End
Item	DWR UCIP Field Study			37.701912 °	37.701912 °
				-121.161642 °	-121.161642 °
DWR ID					
Comment Code					
Inspector Comment					
FS_ID:20046					
DS_ID:20440					
EP_NO: N/A					
Repair Type: Non-Urgent					
Crossing Status: Found					
UCIP Comments: Alfalfa valve on the WS toe is damaged.					
FIELD_STRUCT_DESC: 30-inch corrugated metal irrigation pipe through the levee 5.0-feet below the crown. Flashboard slots in concrete headwall on the landward side. Distribution box with alfalfa valve on the waterward side. Installed by USACE, 1966. Replaced a 30-inch pipe at same location.					
FS Date: 9/11/2013

Concrete headwall and pipe at concrete channel along landside shoulder of levee.

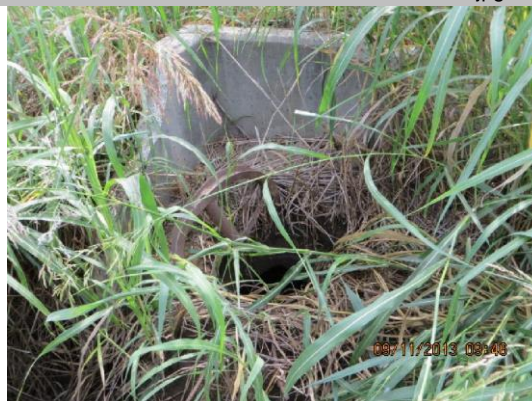
Photo 2 of 2 : UCIP_FA_2016_20046_33945.jpg

Concrete headwall and damaged alfalfa valve on WS toe.

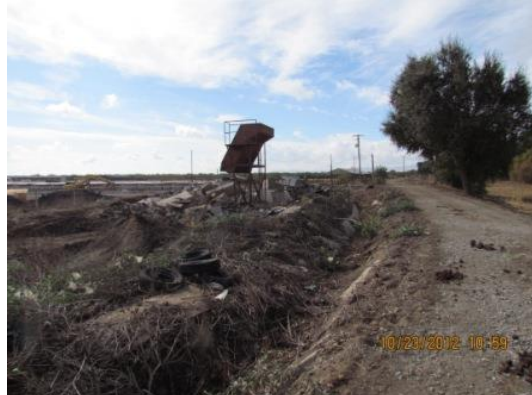
Photo 1 of 1 : FA_2016_RD2031_307_972_20160914_00042.jpg

View of the ditch on landside levee toe, facing downstream.

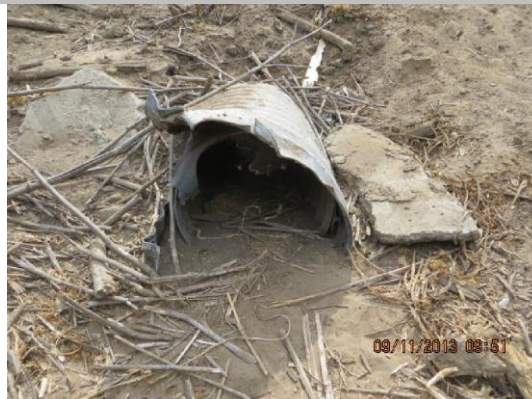
Photo 1 of 2 : UCIP_FA_2016_20047_33950.jpg

LM Start	0.75	Rating **	M	Issue No.	985
LM End	0.75	Issue Type +	En	Location *	LS
Category	Supplemental			GPS Latitude/Longitude	
				Start	End
Item	DWR UCIP Field Study			37.701552 °	37.701552 °
				-121.161883 °	-121.161883 °
DWR ID					
Comment Code					
Inspector Comment					
FS_ID:20047					
DS_ID:20441					
EP_NO: N/A					
Repair Type: Non-Urgent					
Crossing Status: Found					
UCIP Comments: This pipe appears abandoned and if so, should be done so appropriately.					
FIELD_STRUCT_DESC: 15-inch corrugated metal pipe through levee 4.0 feet below crown. Flashboard slots on the landward side. Installed by USACE 1966. Originally included in the 1968 O&M manual.					
FS Date: 9/11/2013

Damaged CMP pipe on WS slope.

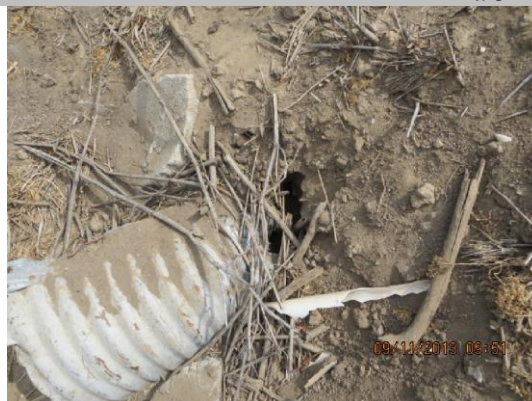
Photo 2 of 2 : UCIP_FA_2016_20047_33949.jpg

Hole in pipe at WS slope.

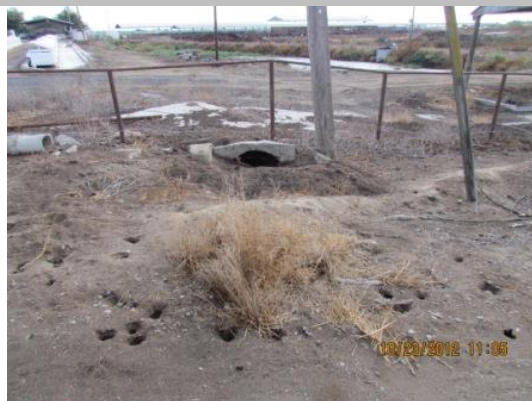
Photo 1 of 1 : FA_2016_RD2031_307_36_20160914_00021.jpg

LM Start	0.77	Rating **	M	Issue No.	36
LM End	0.77	Issue Type +	Ma	Location *	LS
Category	Earthen Levee			GPS Latitude/Longitude	
				Start	End
Item	Animal Control			37.701177 °	37.701177 °
				-121.162055 °	-121.162055 °
DWR ID	DWR_RD2031_01_f_2012_36				
Comment Code					
A3 : No rodents visible, but rodent burrows visible; need to backfill and compact or grout burrows.					
Inspector Comment

View of rodent burrows on landside slope.

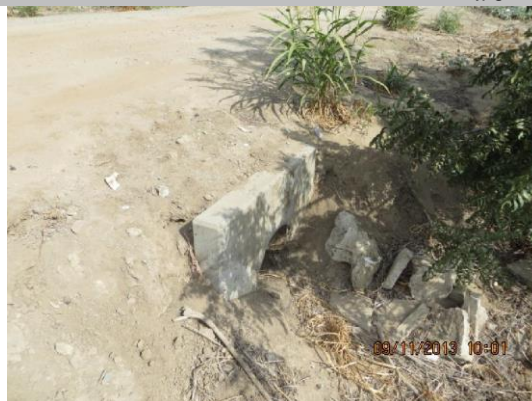
Photo 1 of 2 : UCIP_FA_2016_20049_33956.jpg

LM Start	0.80	Rating **	M	Issue No.	986
LM End	0.80	Issue Type +	En	Location *	LS
Category	Supplemental			GPS Latitude/Longitude	
				Start	End
Item	DWR UCIP Field Study			37.700853 °	37.700853 °
				-121.162349 °	-121.162349 °
DWR ID					
Comment Code					
Inspector Comment					
FS_ID:20049 DS_ID:20443 EP_NO: N/A Repair Type: Non-Urgent Crossing Status: Found UCIP Comments: Pipe appears abandoned as WS slope is covered with soil. If abadoned, it should be done so properly. FIELD_STRUCT_DESC: 24-inch steel pipe through levee 2.0-feet below the crown. Concrete headwall on both sides of levee crown. FS Date: 9/11/2013

Open pipe and headwall on LS slope.

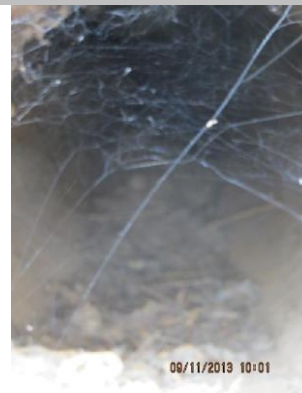
Photo 2 of 2 : UCIP_FA_2016_20049_33955.jpg

Pipe not filled with concrete.

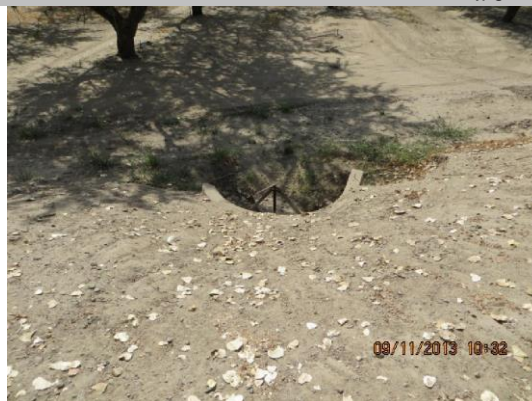
Photo 1 of 2 : UCIP_FA_2016_47158_74940.jpg

LM Start	0.92	Rating **	M	Issue No.	997
LM End	0.92	Issue Type +	En	Location *	CR
Category	Supplemental			GPS Latitude/Longitude	
				Start	End
Item	DWR UCIP Field Study			37.699692 °	37.699692 °
				-121.163977 °	-121.163977 °
DWR ID					
Comment Code					
Inspector Comment					
FS_ID:47158					
DS_ID:20444					
EP_NO: N/A					
Repair Type: Non-Urgent					
Crossing Status: Indicator Found					
UCIP Comments: Need site visit by UCIP--Concrete headwall present on landward side toe. Need to coordinate with owner to determine if this headwall is for 24-inch pipe or if the structure is part of drainage system that could run parallel to levee.					
FIELD_STRUCT_DESC: 24-inch pipe through levee 3.5 feet below crown. Flap gate on the waterward end.					
FS Date: 9/10/2013

Concrete structure located on landward side toe.

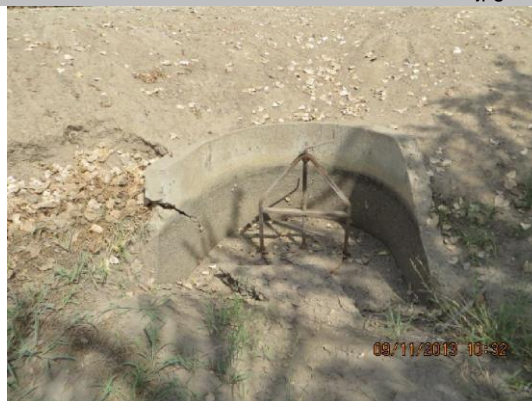
Photo 2 of 2 : UCIP_FA_2016_47158_74941.jpg

Front view of concrete structure located on landward toe.

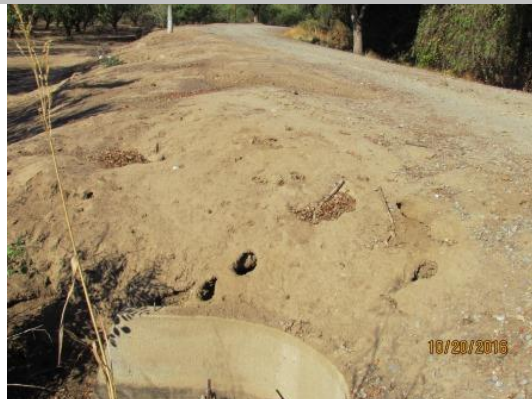
Photo 1 of 1 : FA_2016_RD2031_307_44_20161024_00093.jpg

View of the rodent holes on the landside levee slope.

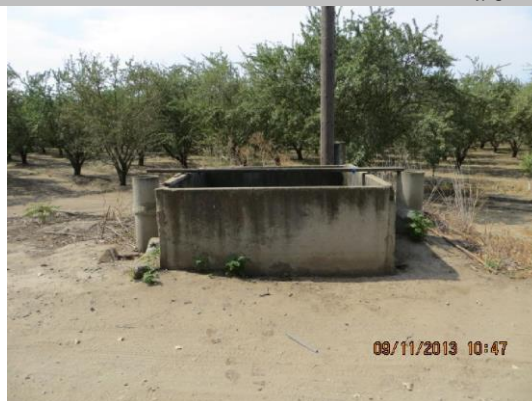
Photo 1 of 2 : UCIP_FA_2016_20085_34010.jpg

LM Start	1.27	Rating **	M	Issue No.	987
LM End	1.27	Issue Type +	En	Location *	LS
Category	Supplemental			GPS Latitude/Longitude	
				Start	End
Item	DWR UCIP Field Study			37.699480 °	37.699480 °
				-121.169850 °	-121.169850 °
DWR ID					
Comment Code					
Inspector Comment					
FS_ID:20085					
DS_ID:20445					
EP_NO: N/A					
Repair Type: Non-Urgent					
Crossing Status: Found					
UCIP Comments: Pipe corroded through at distribution box. Appears abandoned and should be done so properly.					
FIELD_STRUCT_DESC: 1 of 2: 12-inch steel pipe through the levee 3.3-feet below the crown. Pump missing from pile structure on the riverbank. Concrete distribution box on the landward side. Installed by USACE, 1966. Also included in 1968 O&M manual.					
FS Date: 9/11/2013

Concrete distribution box on LS shoulder.

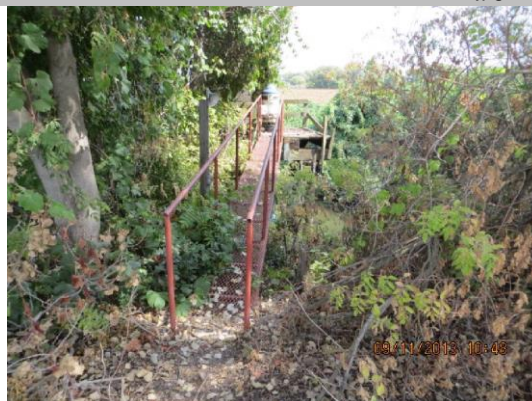
Photo 2 of 2 : UCIP_FA_2016_20085_34009.jpg

Pump on pier on WS slope.

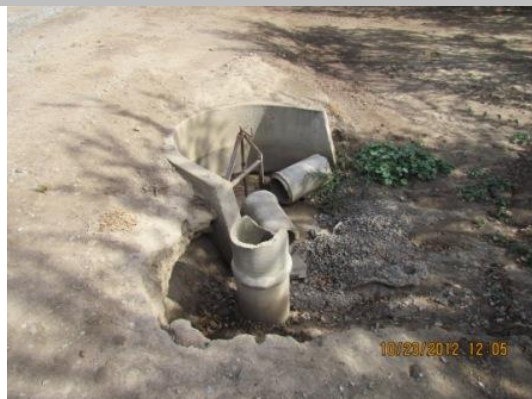
Photo 1 of 2 : FA_2016_RD2031_307_3_20160914_00006.jpg

View of the erosion site on landside slope, facing upstream.

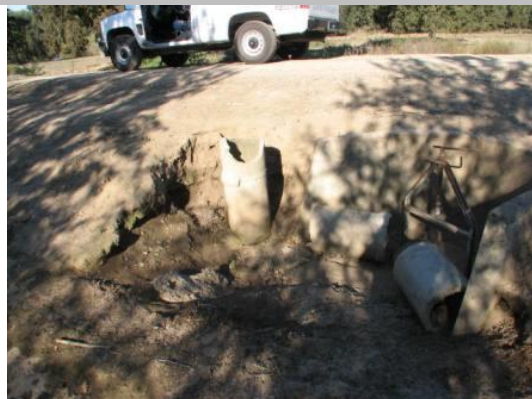
Photo 2 of 2 : FA_2016_RD2031_307_3_20160914_00007.jpg

10/26/2011 Active erosion into the levee prism around irrigation standpipe.

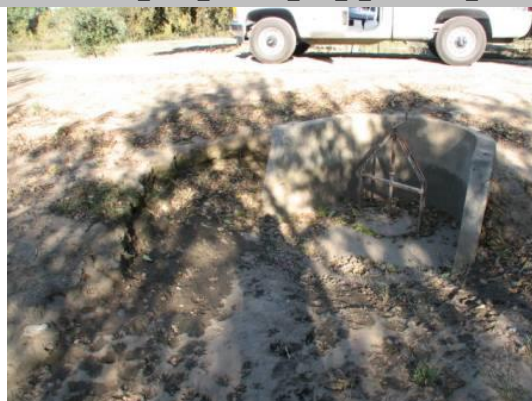
Photo 1 of 1 : FA_2016_RD2031_307_8_20160914_00012.jpg

10/26/2011 Active erosion shown around irrigation inlet.

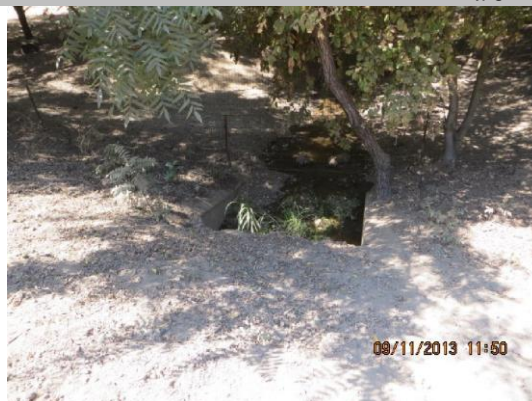
Photo 1 of 2 : UCIP_FA_2016_41354_34034.jpg

FS_ID:41354
DS_ID:20470
EP_NO: N/A
Repair Type: Non-Urgent
Crossing Status: Found
UCIP Comments: Silt buildup at inlet and outlet.
FIELD_STRUCT_DESC: 1 of 2: 24-inch corrugated metal pipe through the levee 9.5-feet below the crown. Concrete "U"-shaped headwalls on both ends. Flap gate on the waterward end. Installed by USACE, 1966. Also included in the 1968 O&M manual.
FS Date: 9/11/2013

Concrete headwall on WS toe.

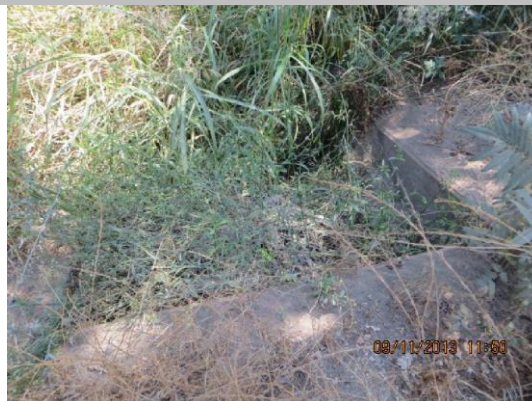
Photo 2 of 2 : UCIP_FA_2016_41354_34033.jpg

Concrete headwall on LS toe.

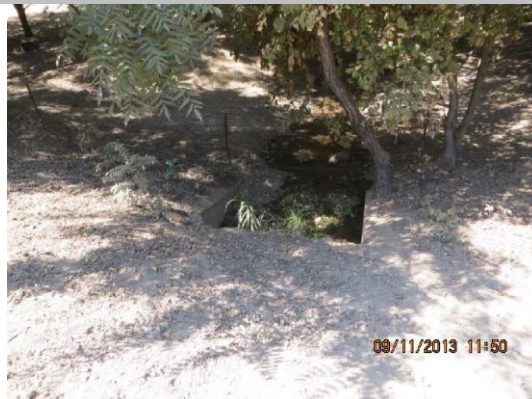
Photo 1 of 2 : UCIP_FA_2016_20092_34041.jpg

FS_ID:20092
DS_ID:20447
EP_NO: N/A
Repair Type: Non-Urgent
Crossing Status: Found
UCIP Comments: Silt buildup at inlet and outlet.
FIELD_STRUCT_DESC: 2 of 2: 24-inch corrugated metal pipe through the levee 9.5-feet below the crown. Concrete "U"-shaped headwalls on both ends. Flap gate on the waterward end. Installed by USACE, 1966. Also included in the 1968 O&M manual.
FS Date: 9/11/2013

Concrete U-shaped headwall on WS toe.

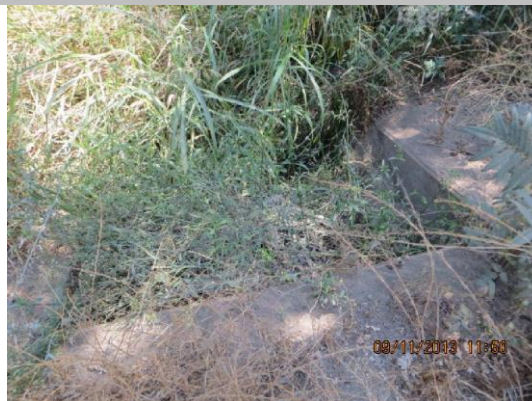
Photo 2 of 2 : UCIP_FA_2016_20092_34040.jpg

Concrete U-shaped headwall on LS toe.

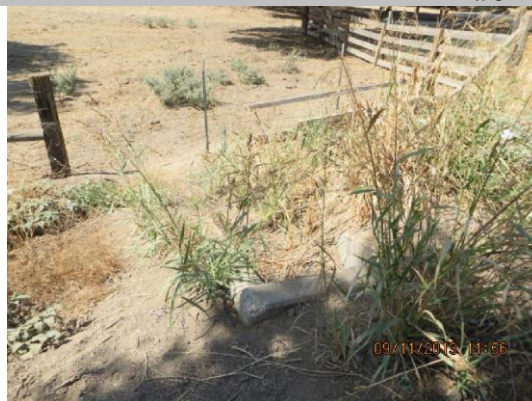
Photo 1 of 2 : UCIP_FA_2016_20109_34075.jpg

FS_ID:20109
DS_ID:20448
EP_NO: N/A
Repair Type: Non-Urgent
Crossing Status: Found
UCIP Comments: If abandoned it should be done so properly if not, the pipe should be cleared of soil blockage.
FIELD_STRUCT_DESC: *ABANDONED* 24-inch pipe through levee 6.8 feet below crown. Concrete headwalls on both ends. Flap gate on the waterward end. Installed by USACE, 1966.
FS Date: 9/11/2013

Concrete U-shaped headwall on WS toe.

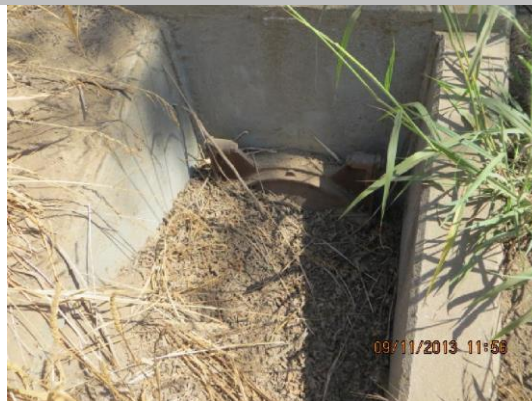
Photo 2 of 2 : UCIP_FA_2016_20109_34074.jpg

Flapgate on WS toe.

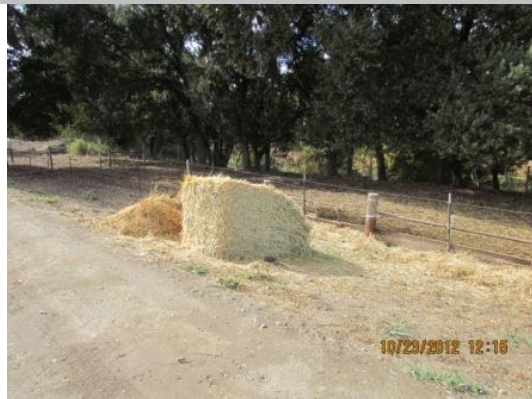
Photo 1 of 1 : FA_2016_RD2031_307_39_20160914_00023.jpg

View of hay bales at toe of levee on waterward side, facing downstream.
05/02/2012

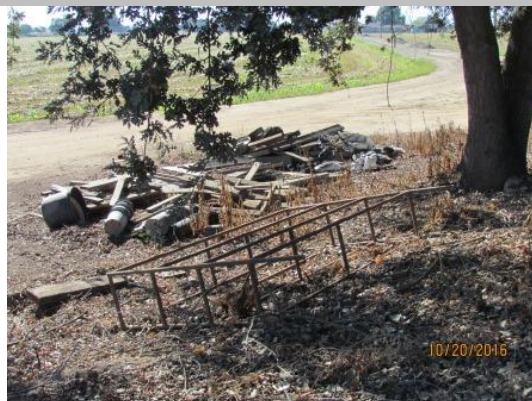
Photo 1 of 2 : FA_2016_RD2031_307_53_20161024_00097.jpg

View of the debris at the landside levee toe.

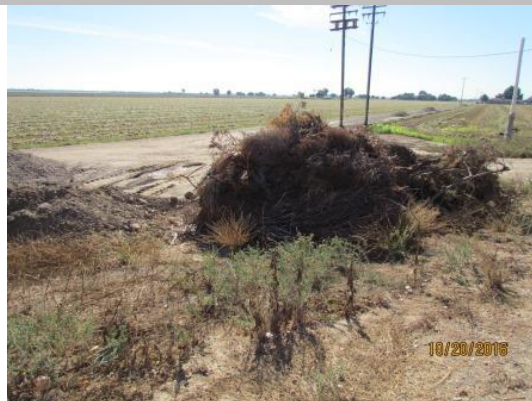
Photo 2 of 2 : FA_2016_RD2031_307_53_20161024_00098.jpg

View of another debris pile in close proximity of the previous photo.

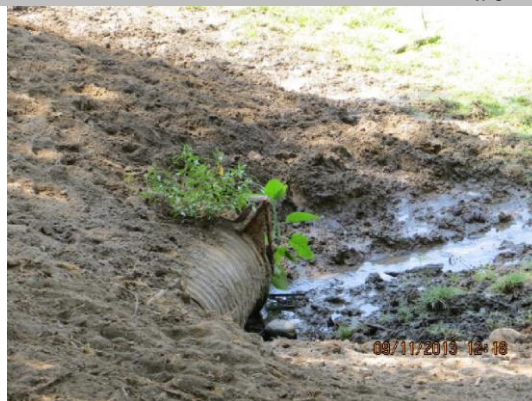
Photo 1 of 2 : UCIP_FA_2016_50753_39002.jpg

FS_ID:50753
DS_ID:24669
EP_NO: N/A
Repair Type: Non-Urgent
Crossing Status: Found
UCIP Comments: 11/16/2016 No access to WS due to cattle fence in place. Need to coordinate with property owner to obtain access on WS. Unable to find inlet on LS. Recommend internal inspection of crossing. Crossing has been downgraded from Urgent to Non-Urgent no signs of leaks where present on crown or slopes where pipe should be. (O. Magana - DWR UCIP)09/11/2013 Flapgate partially blocked by soil on WS toe. Good candidate for video inspection. (W. Wylie - DWR UCIP) FIELD_STRUCT_DESC: 24-inch corrugated metal drainage pipe through the levee at an unknown depth. Flapgate is located on the waterside (WS) toe. Pipe may originate at concrete distribution box on LS toe.
FS Date: 11/16/2016

Flapgate and pipe visible on WS toe.

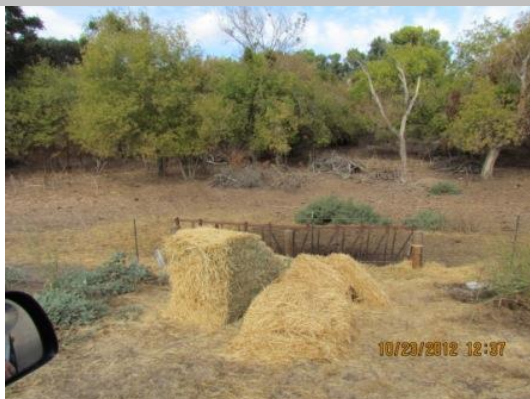
Photo 1 of 1 : FA_2016_RD2031_307_45_20160914_00025.jpg

View of hay bales at toe of levee on waterward side, facing downstream.

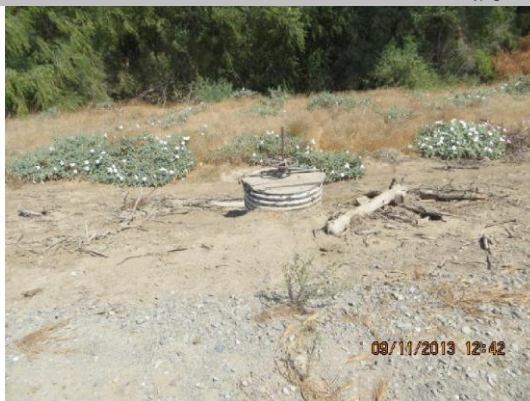
Photo 1 of 2 : UCIP_FA_2016_20449_34506.jpg

LM Start	3.08	Rating **	M	Issue No.	990
LM End	3.08	Issue Type +	En	Location *	WS
Category	Supplemental			GPS Latitude/Longitude	
				Start	End
Item	DWR UCIP Field Study			37.688297 °	37.688297 °
				-121.190865 °	-121.190865 °
DWR ID					
Comment Code					
Inspector Comment					
FS_ID:20449					
DS_ID:20451					
EP_NO: N/A					
Repair Type: Non-Urgent					
Crossing Status: Found					
UCIP Comments: Pipe appears to be abandoned and if so should be done so properly.					
FIELD_STRUCT_DESC: *ABANDONED* 24-inch corrugated metal pipe through levee 14.0 feet below crown. Slide gate in 36-inch corrugated metal pipe riser on the waterward slope. Originally included in the 1968 O&M manual.					
FS Date: 9/11/2013

Slide gate in CMP riser on WS slope.

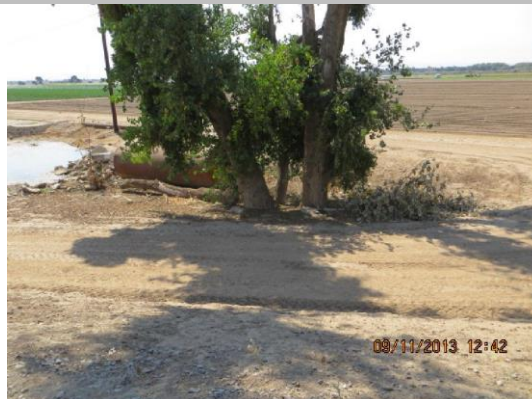
Photo 2 of 2 : UCIP_FA_2016_20449_34505.jpg

Pipe not visible on LS toe.

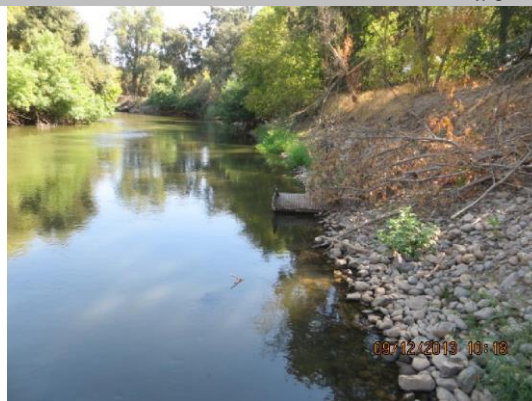
Photo 1 of 2 : UCIP_FA_2016_23064_39200.jpg

LM Start	3.66	Rating **	M	Issue No.	995
LM End	3.66	Issue Type +	En	Location *	LS
Category	Supplemental			GPS Latitude/Longitude	
				Start	End
Item	DWR UCIP Field Study			37.689900 °	37.689900 °
				-121.198319 °	-121.198319 °
DWR ID					
Comment Code					
Inspector Comment					
FS_ID:23064					
DS_ID:20478					
EP_NO: N/A					
Repair Type: Non-Urgent					
Crossing Status: Found					
UCIP Comments: Good candidate for video inspection.					
FIELD_STRUCT_DESC: 24-inch CMP drainpipe through levee 5.5 feet below crown. Flapgate visilbe at WS toe. Originally included in the 1968 O&M manual.					
FS Date: 9/12/2013

CMP pipe and flapgate visible at WS toe.

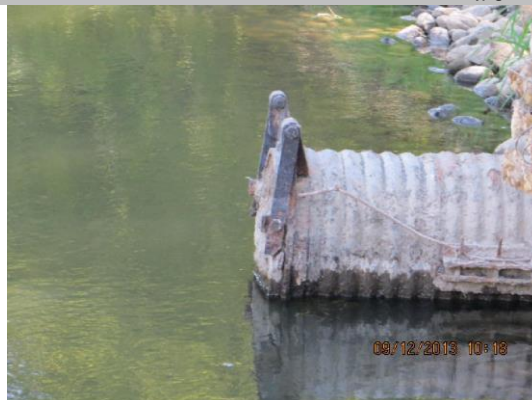
Photo 2 of 2 : UCIP_FA_2016_23064_39199.jpg

CMP pipe and flapgate visible at WS toe.

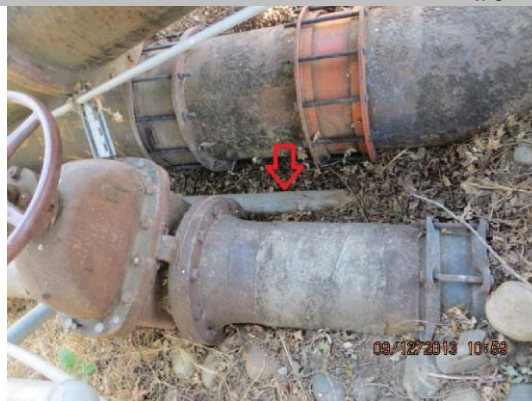
Photo 1 of 2 : UCIP_FA_2016_22843_39015.jpg

LM Start	3.69	Rating **	M	Issue No.	992
LM End	3.69	Issue Type +	En	Location *	LS
Category	Supplemental			GPS Latitude/Longitude	
				Start	End
Item	DWR UCIP Field Study			37.689742 °	37.689742 °
				-121.198778 °	-121.198778 °
DWR ID					
Comment Code					
Inspector Comment					
FS_ID:22843 DS_ID:24672 EP_NO: N/A Repair Type: Non-Urgent Crossing Status: Found UCIP Comments: No permit identified for this possible crossing. FIELD_STRUCT_DESC: 4-inch steel irrigation line through the levee at unknown depth. Pipe visible between larger irrigation pipes below slant pump on WS slope. FS Date: 9/12/2013

Pipe visible between larger irrigation pipes below slant pump on WS slope.

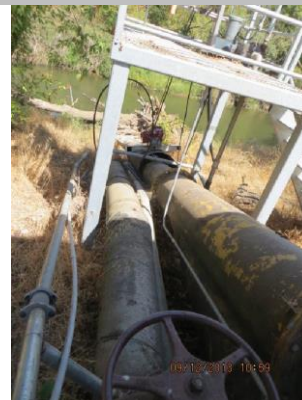
Photo 2 of 2 : UCIP_FA_2016_22843_39014.jpg

Pipe visible between larger irrigation pipes below slant pump on WS slope.

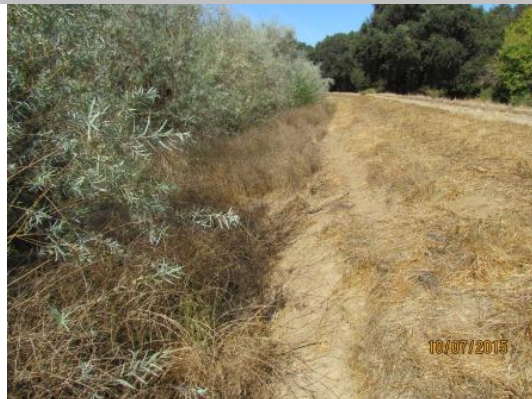
Photo 1 of 1 : FA_2016_RD2031_307_57_20160914_00033.jpg

View of the 18 inch vertical cut at the landside levee toe.

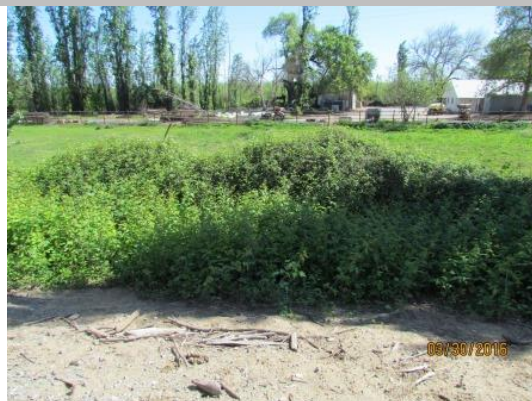
Photo 1 of 1 : FA_2016_RD2031_307_43_20160914_00024.jpg

View of the tall vegetation on the landside levee slope and toe.

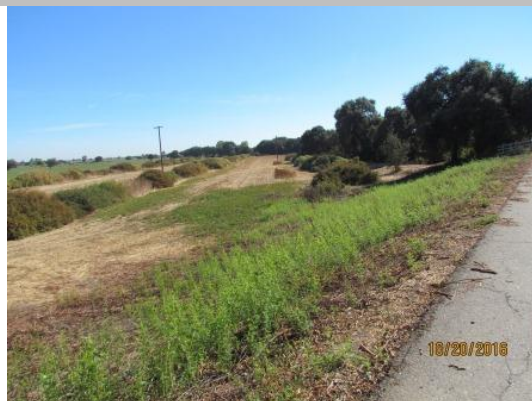
Photo 1 of 2 : FA_2016_RD2031_308_965_20161024_00035.jpg

View of wild rose emerging on levee slope. Fall 2016.

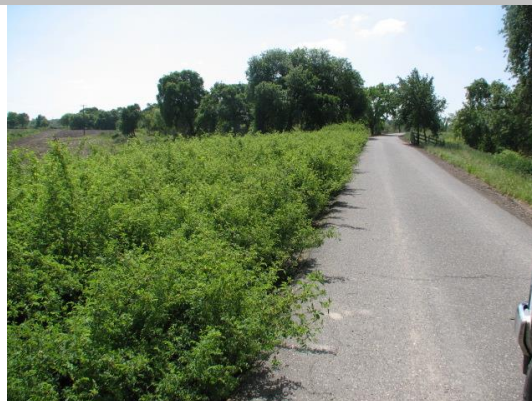
Photo 2 of 2 : FA_2016_RD2031_308_965_20160914_00010.jpg

Wild rose on levee slope.

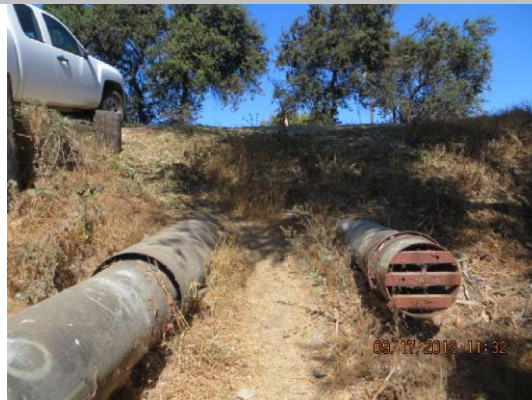
Photo 1 of 2 : UCIP_FA_2016_20718_34856.jpg

Pipe at right-abandoned.

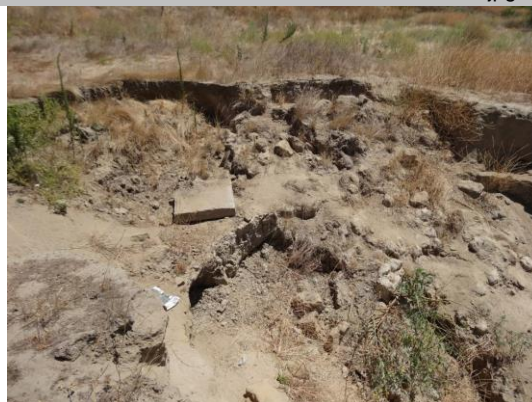
Photo 2 of 3 : SJR2016_RD2031U02RM78.7_3.jpg

Close view of the pocket erosion.

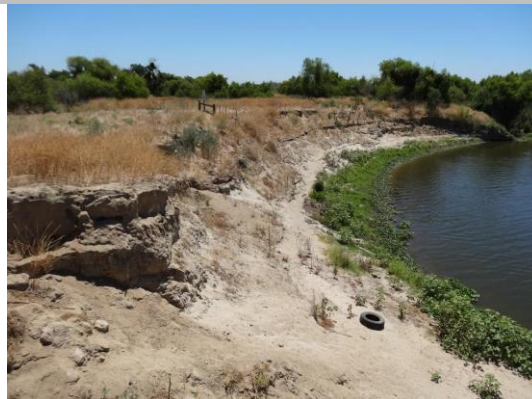
Photo 3 of 3 : SJR2016_RD2031U02RM78.7_4.jpg

Close view of the erosion.
